NASA TECHNICAL NOTE

NASA TN D-2685

SEALED-FOAM, CONSTRICTIVE-WRAPPED,
EXTERNAL INSULATION SYSTEM
FOR LIQUID-HYDROGEN TANKS
OF BOOST VEHICLES

by Lewis Research Center Staff

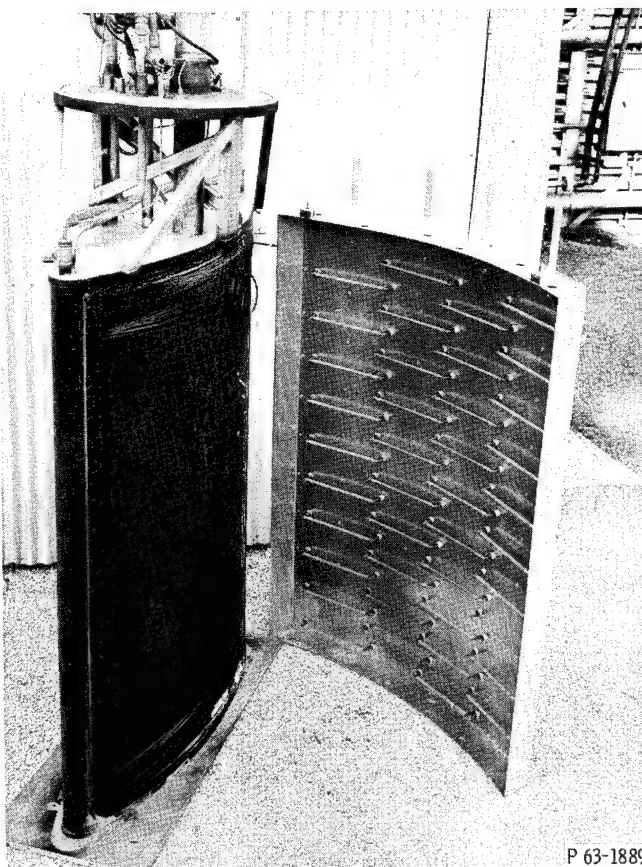
Figure V-9. - Infrared heating lamp assembly for simulating aerodynamic heating of insulation surface on circular-segment tanks. (Insulation surface painted black)

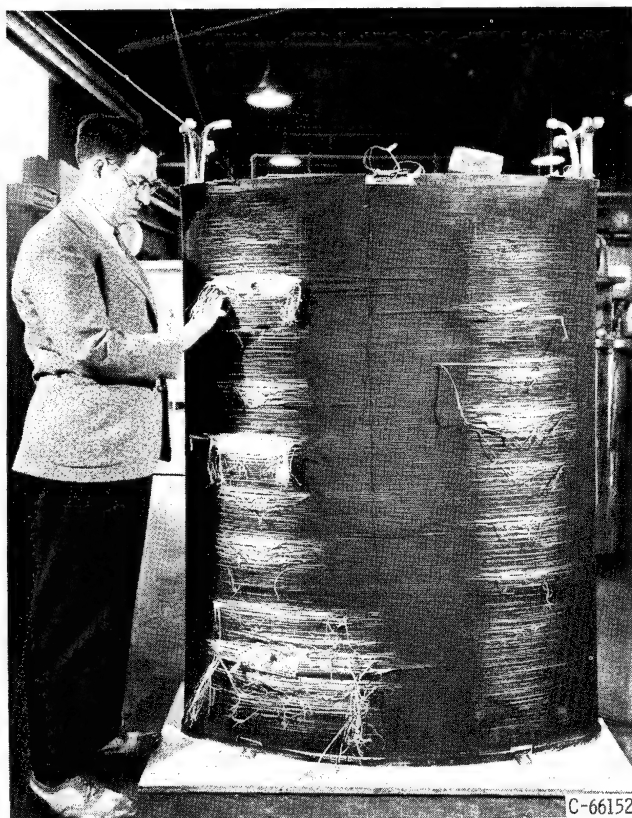
Figure V-12. - Insulation system 1 after being subjected to simulated launch tests. Maximum surface temperatures unknown.

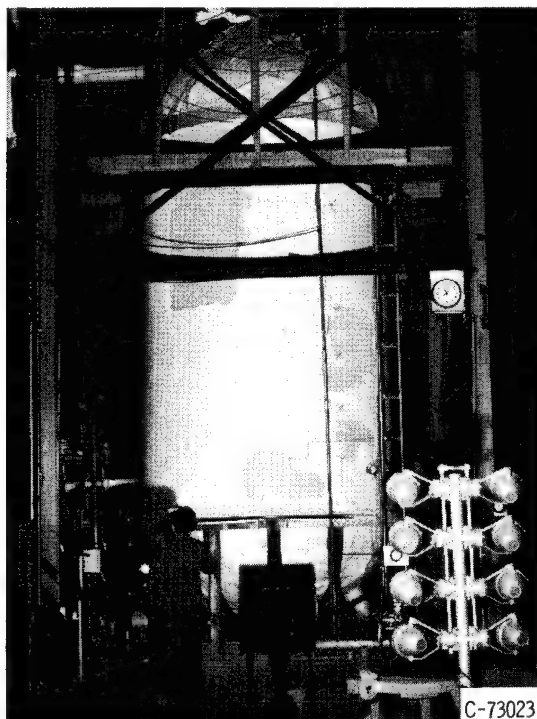
(d) 11:09 p. m.

Figure VIII-7. - Frost falloff as insulation warmed up.

tank. Generally, the area of the insulation that blistered was only a fraction of the frost-falloff area. For example, a 16-square-inch blistered area of insulation resulted in a frost-falloff area of approximately 600 square inches. This was caused by the low adhesive forces between the frost and the insulation.

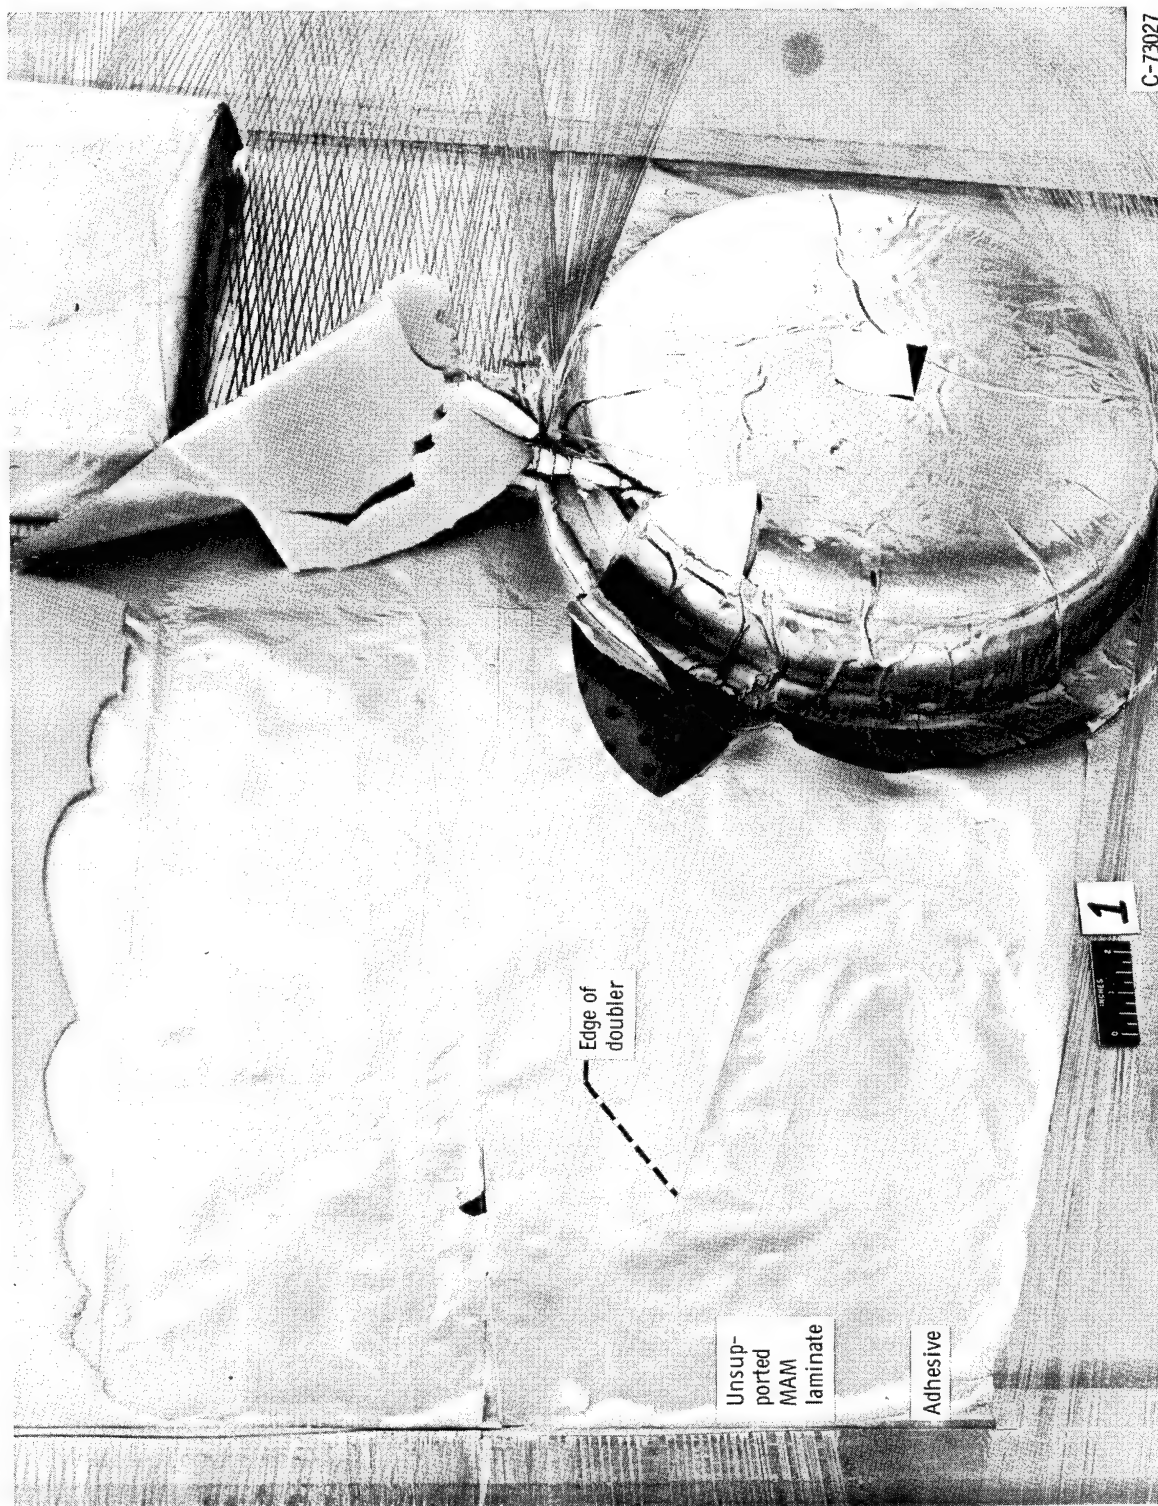
(a) Before examination.

(b) MAM laminate folded back exposing cracked foam.

(c) Cracked foam removed.

(d) Inside layer of MAM laminate exposed showing impression of doubler.

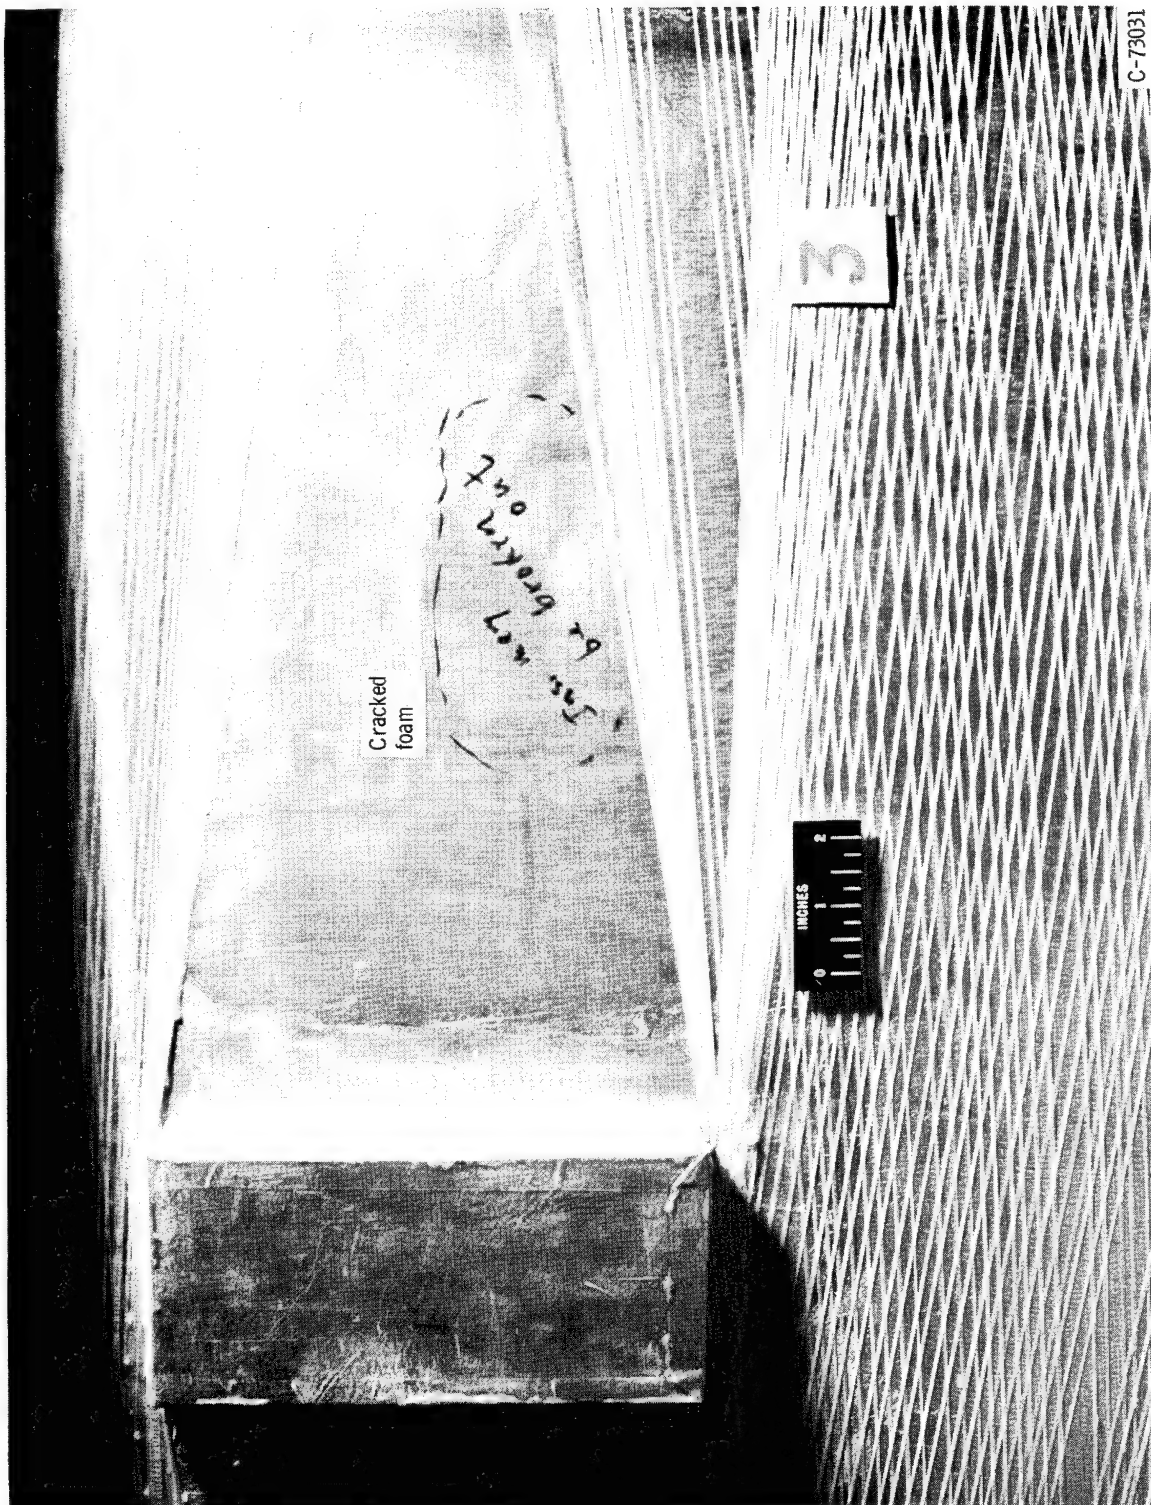
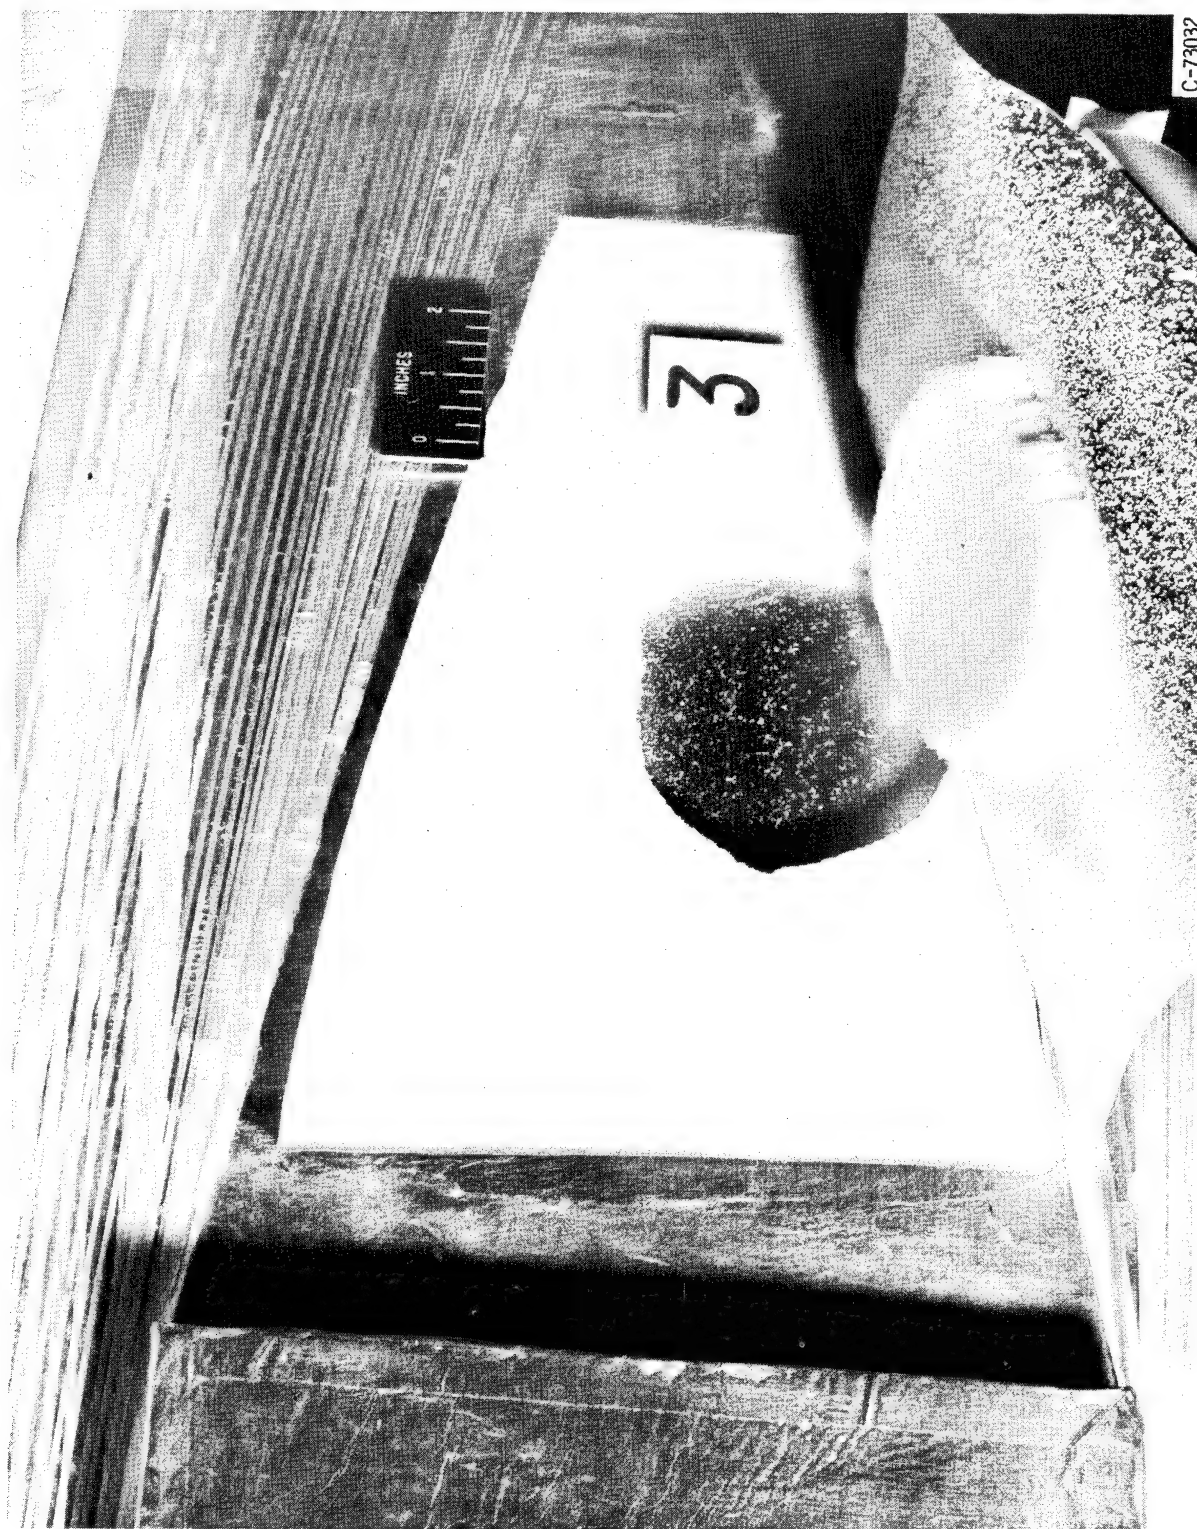
(a) Before examination.

(b) MAM laminate and cracked foam folded back.

(c) Inside layer of MAM laminate removed.
